DUMPSITE RISK MITIGATION FINAL REPORT

Title: Dumpsite Risk Mitigation / Final Report

June 2018

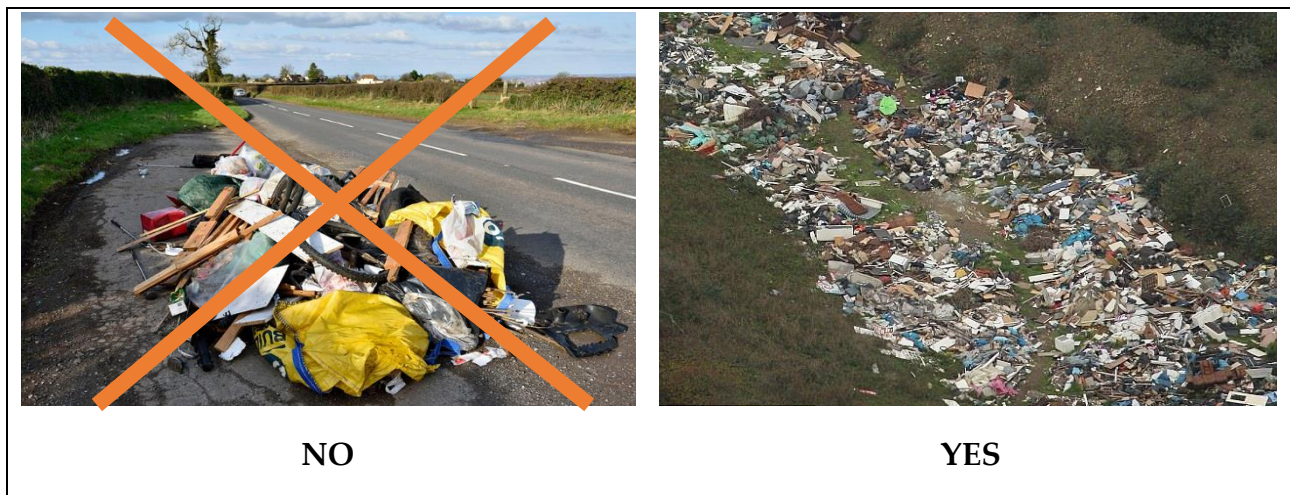
Fig. 2.2 Guiding images of dumpsites that should be considered

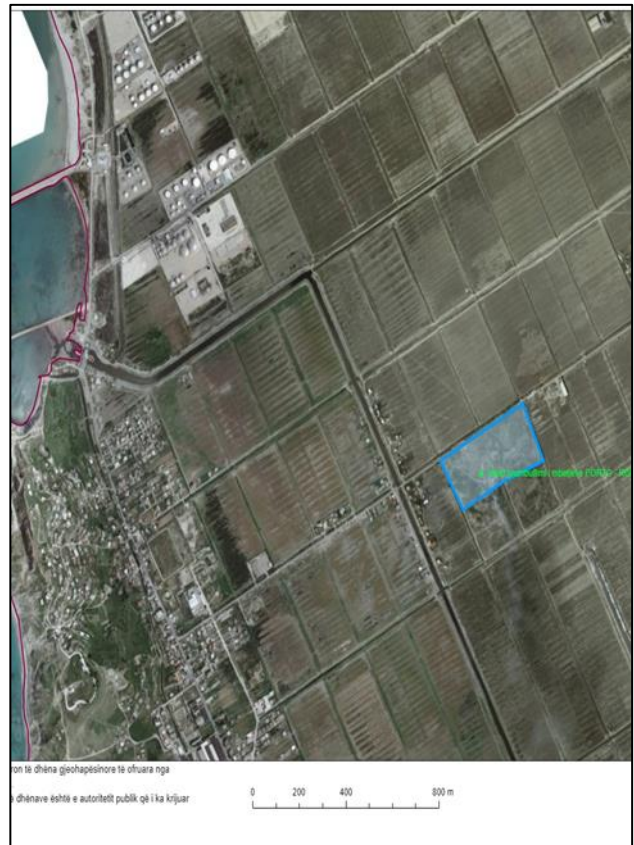
Dumpsite Porto Romano,
Durrës

Fig. 2.4 Material handled by Working Group of M. Madhe and Durrës Municipality

In most cases instead of sketches processed by working group engineers, were handled also scans of property certificates, orthophoto or google map views. This often caused the data did not serve to the scope required in order to calculate the surface area or volumes of dumpsites. Below are some cases of graphic materials handled by local working groups.

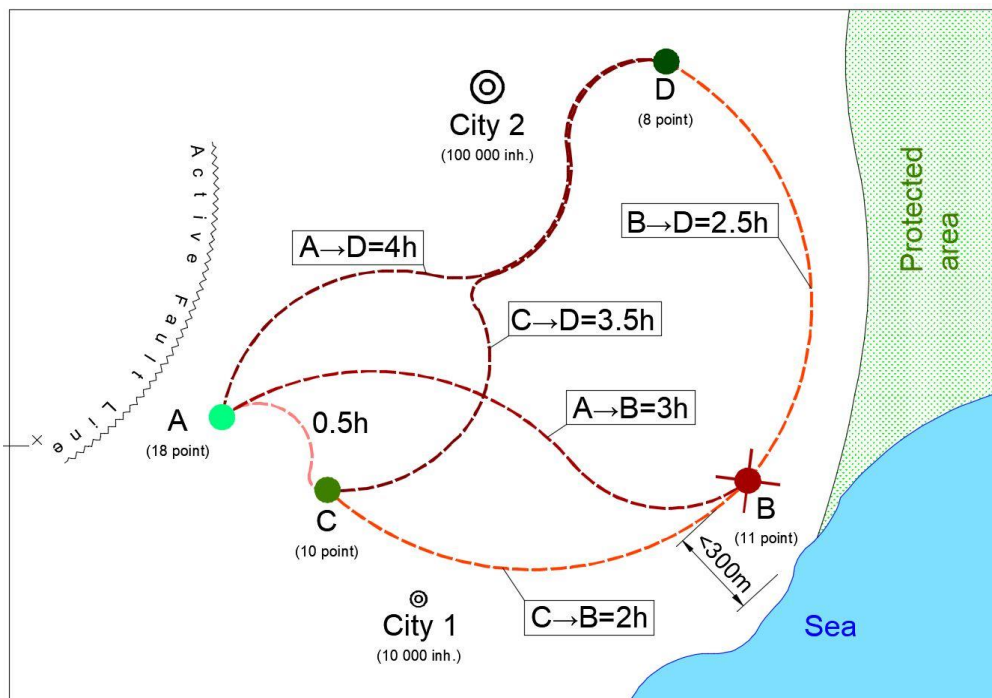
Fig. 2.5 Hypothetic case for interventions at dumpsites

Below is provided a hypothetical case presented in the Methodology, which shows the decision-making process related to the dumpsite.

According to this scenario it turns out:

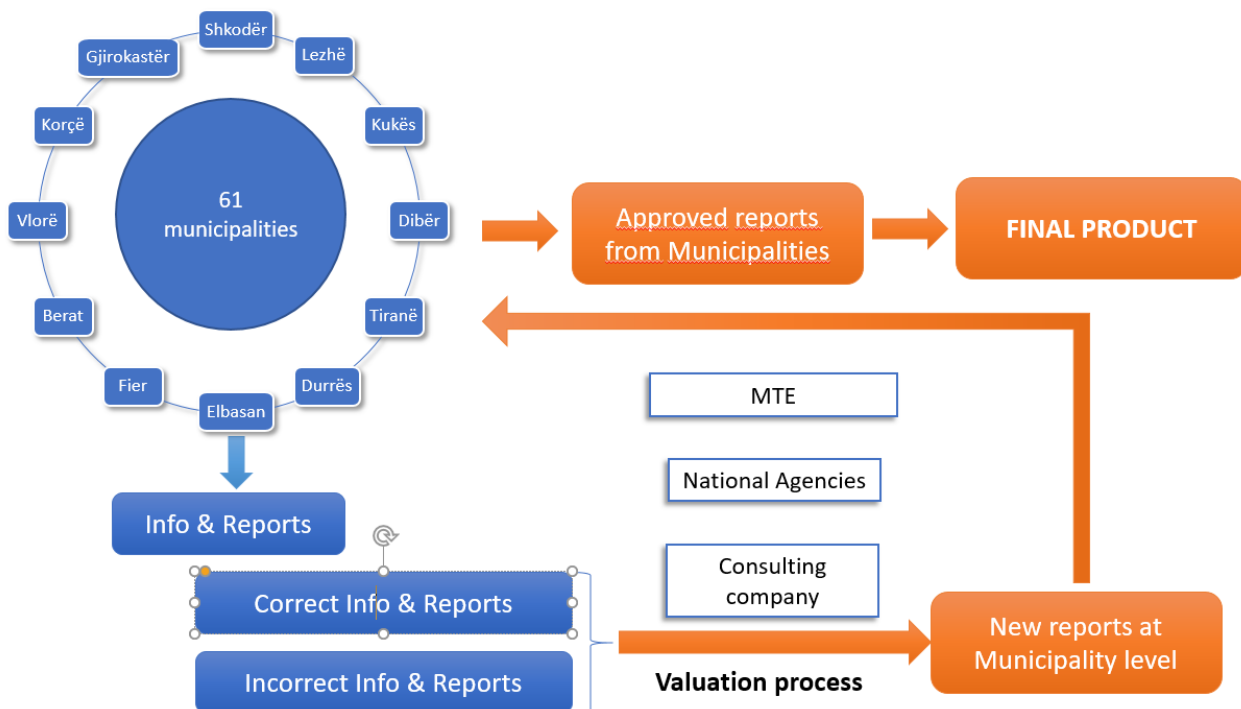
Fig. 4.1 Validation process

After due corrections (where deemed necessary), the reports were prepared once again at municipality level and were delivered among Prefects for final approval from Municipality Mayors. All this process is schematically explained on the following figure.

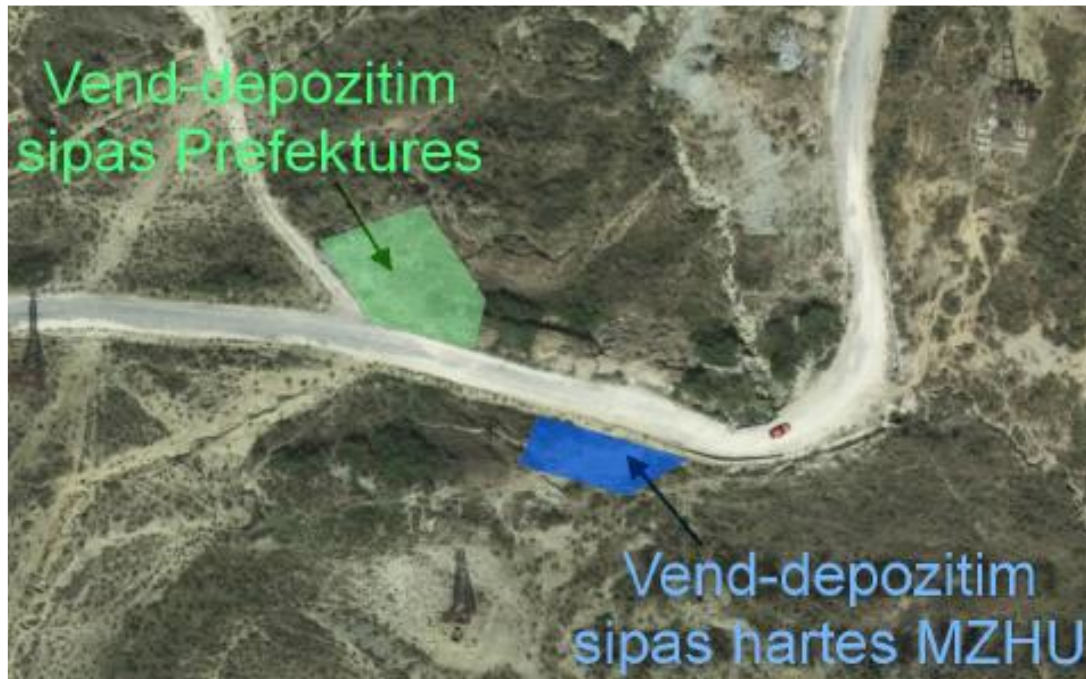
Fig. 4.6 Dumpsites in Selenica Municipality

Case 3: Dumpsites at former MUD map are given in another former position in comparison with those referred to the working groups. A typical case is the one below, at the municipality of Selenica, where the map of former MUD shows the dumpsite down the street, while the working group referred to the upper one. Form orthophoto it is clearly seen that in both positions there are deposited waste.

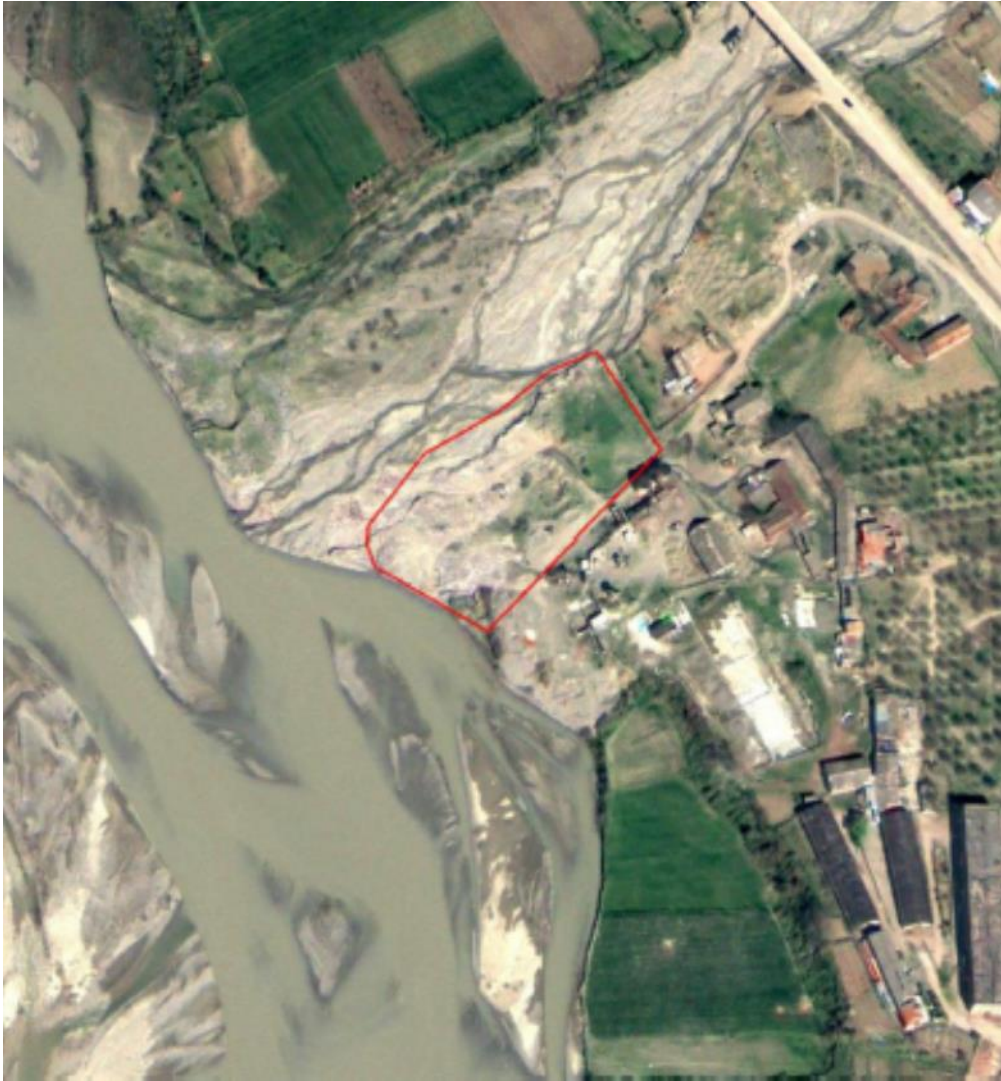
Fig. 4.7 Photo of the displaced dumpsite location in Gramsh

The construction of the Banja hydropower in Devoll cascade, made it necessary to relocate the existing dumpsite because it was flooded by the lake created. Under these conditions, the municipality had approved¹³ the relocation of this dumpsite to the Mashan village of Gramsh.

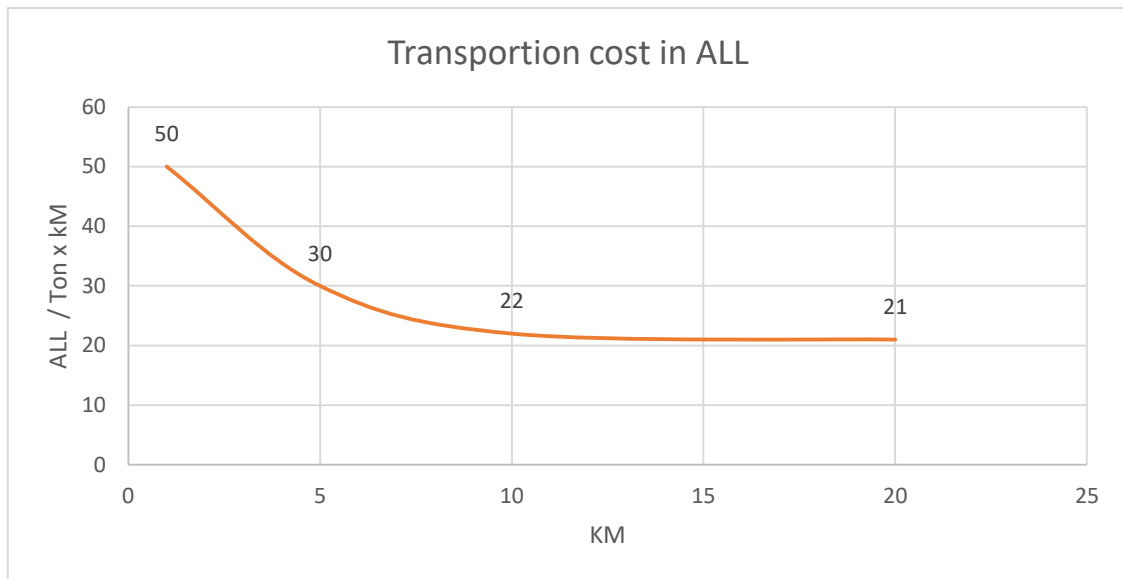
Fig. 4.10 Graph showing transport rate variation

Volume weight	Distance	Product	Rate/ unit weight	Rate/ unit volume	Volume	Rate
Ton/ m^3	km	Ton · km/ m^3	ALL/ Ton · km	ALL/ m^3	m^3	ALL
0.7	1	0.7	50	35	10	350
0.7	5	3.5	30	105	10	1,050
0.7	10	7	22	154	10	1,540
0.7	20	14	21	294	10	2,940
0.7	50	35	21	735	10	7,350

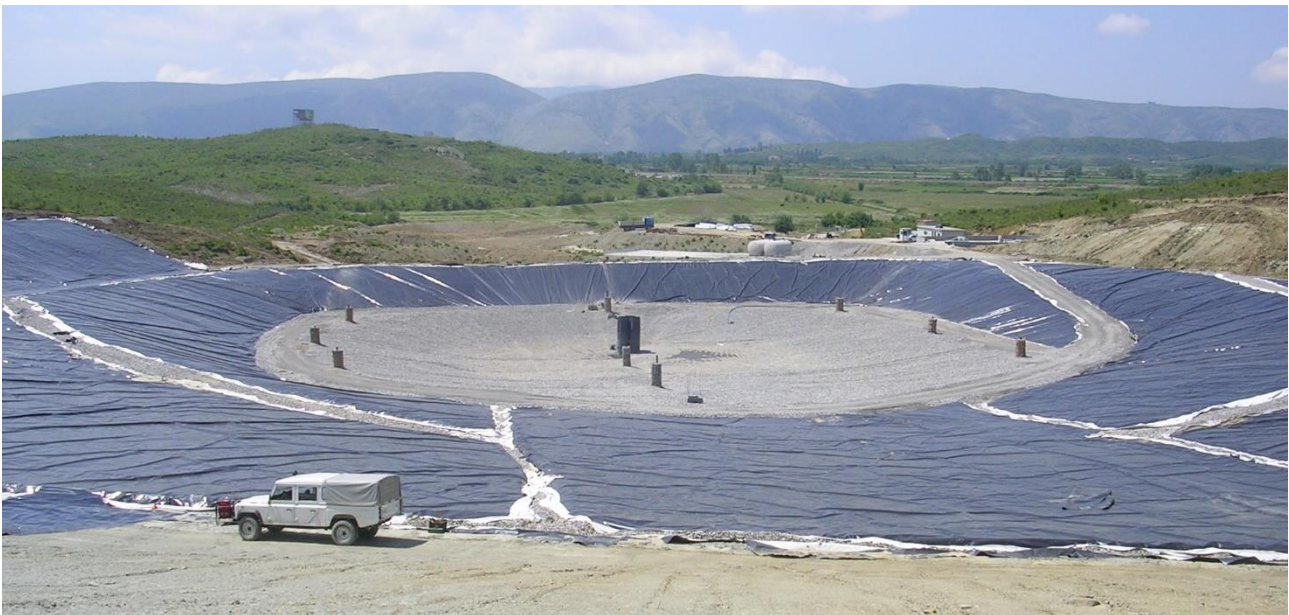
Fig. 7.2 Bushat landfill view

- Serves to a population of approximately 200 000 inhabitants (covering the needs of Lezha and Shkodra Regions).
- Is designed to have a service lifetime of the landfill extends to 20 years.
- Has a depositing rate of waste quantities of 130 tons/day.

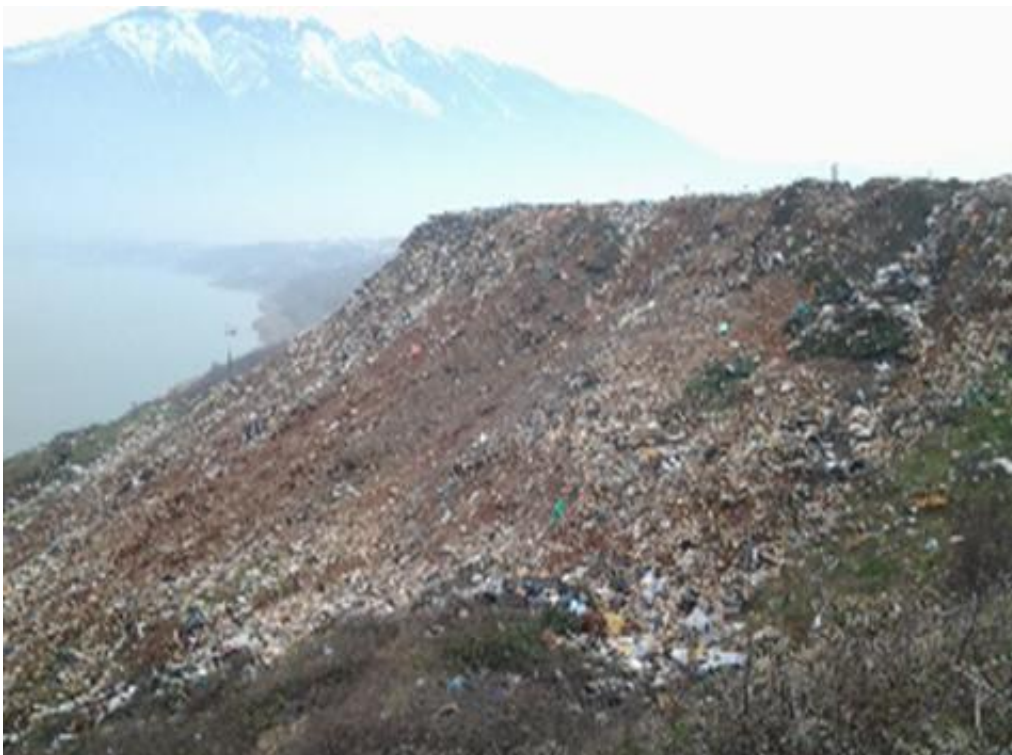
Fig. 7.5 Photo from dumpsite at Bregu mbi Bozhë for inert waste in Kukës

As it can be seen from the Table 7-4 Myç-Mamëz dumpsite is planned for rehabilitation while that in Bregu mbi Bozhë to be closed. These proposals are matching as well the Integrated Waste Management Plan, 2016-2020, for Kukës Municipality²⁹.

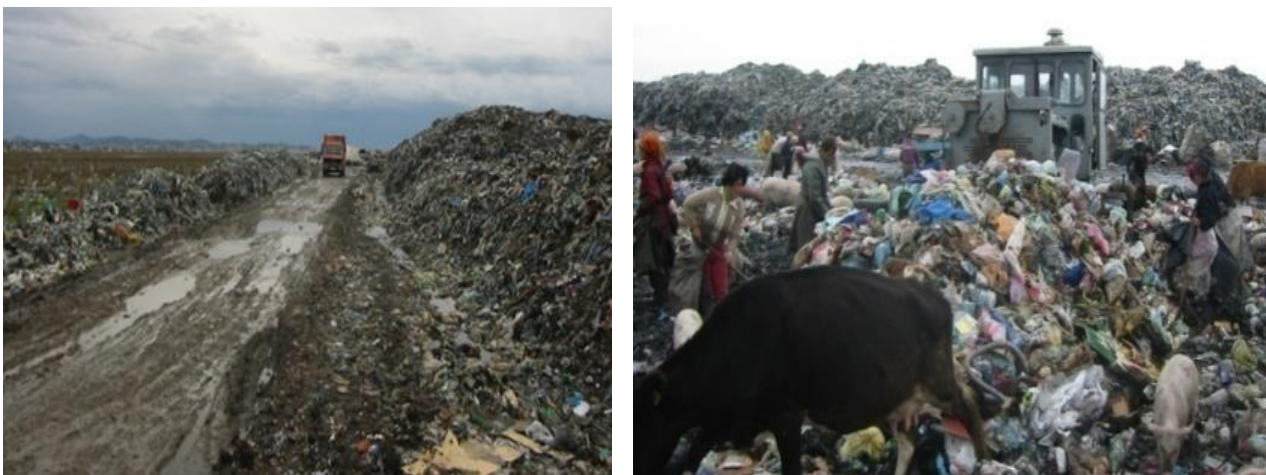
Fig. 7.11 Porto Romano dumpsite, access road view and actual situation

Dumpsite in Porto-Romano is approved with Council decision of Durrës Region with No.1 dated 14.09.1998, and has an area of 5 000 m², while the municipality property available has a total area of 222 000 m². Actually, approximately 80 000 m² are occupied from urban waste. This dumpsite is actually managed from Durrës Municipality Services Company (DMSC), that has in its payroll 5 employees. The personnel mainly manage and compresses the waste volume with a backhoe and a compactor. At the dumpsite entrance is missing the weighting-bridge, consequently the DMSC can only approximate the waste volume deposited there. According the data offered DMSC, during 2017, are deposited 80 000 m² of waste that correspond to 300ton/day. Waste deposited there are coming from Durrës City, Durrës Beach area, Shkozë and villages around.

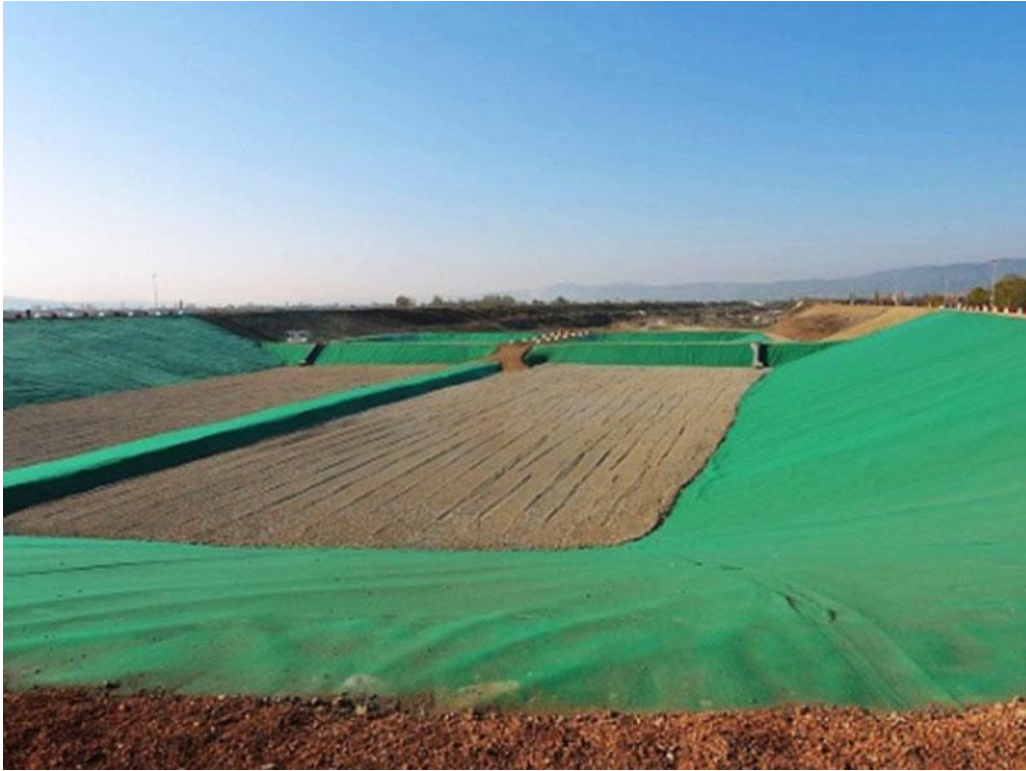
Fig 7 16 View from Elbasan landfill, part of Solid Waste treatment plant

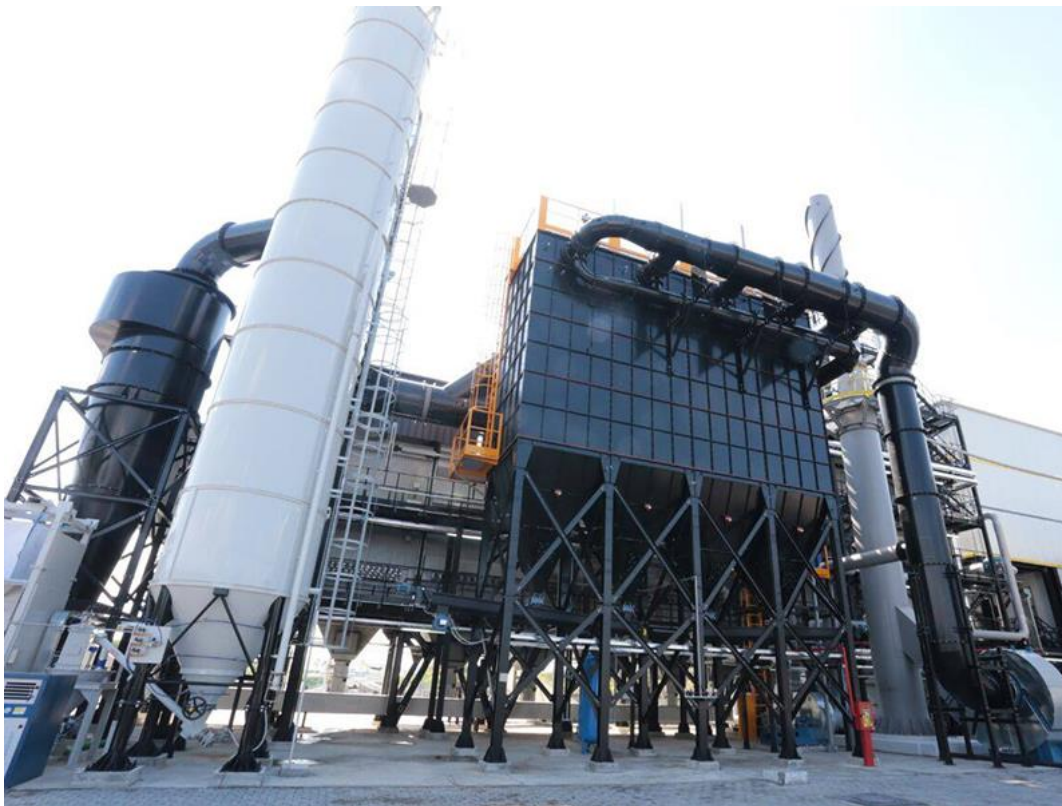
Fig 7 17 View from Energy production plant, Elbasan

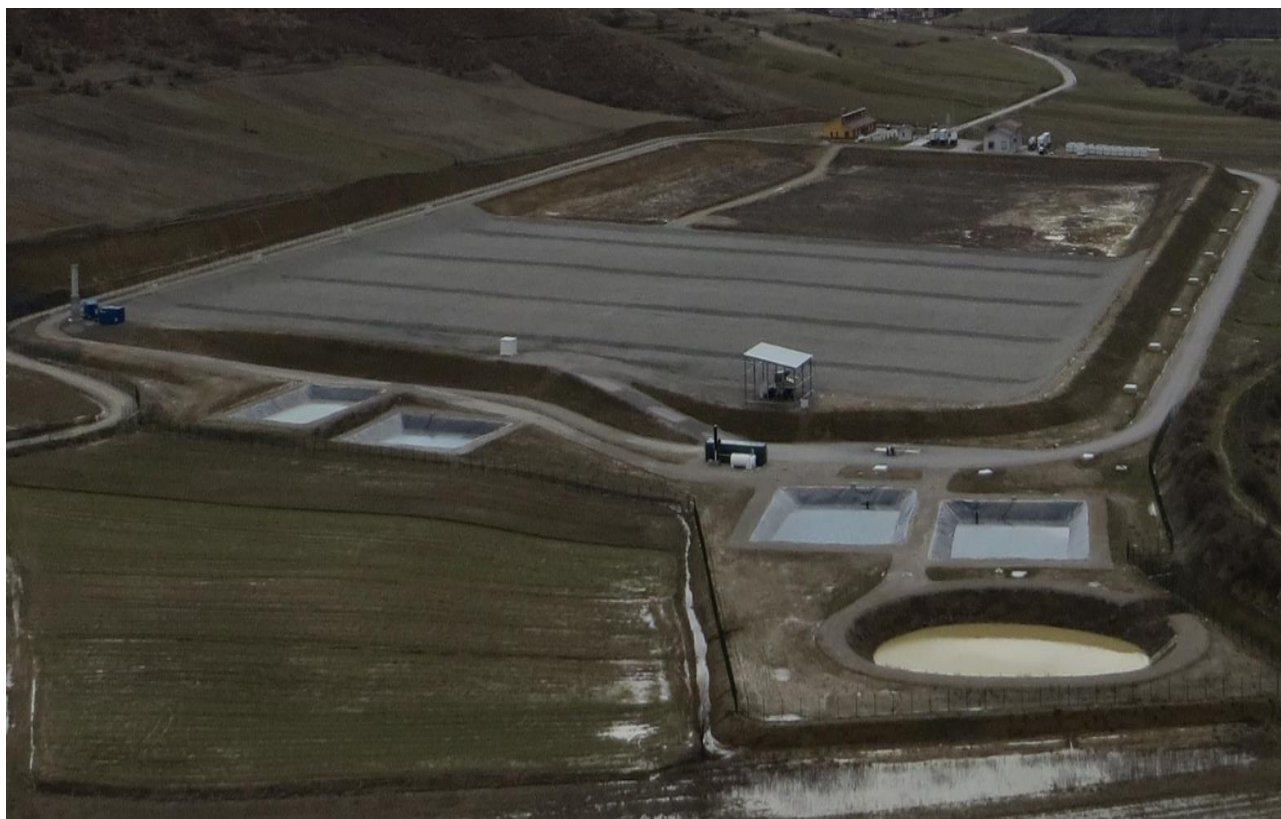
Fig 7 21 View from the landfill of Maliq

1. Construction of a regional sanitary landfill in Maliq,
2. Construction of 3 transfer stations (Pogradec, Devoll and Kolonjë) and necessary equipment,
3. Tools and equipment for improving the existing waste collection service and for pilot activities for recycling/composting.

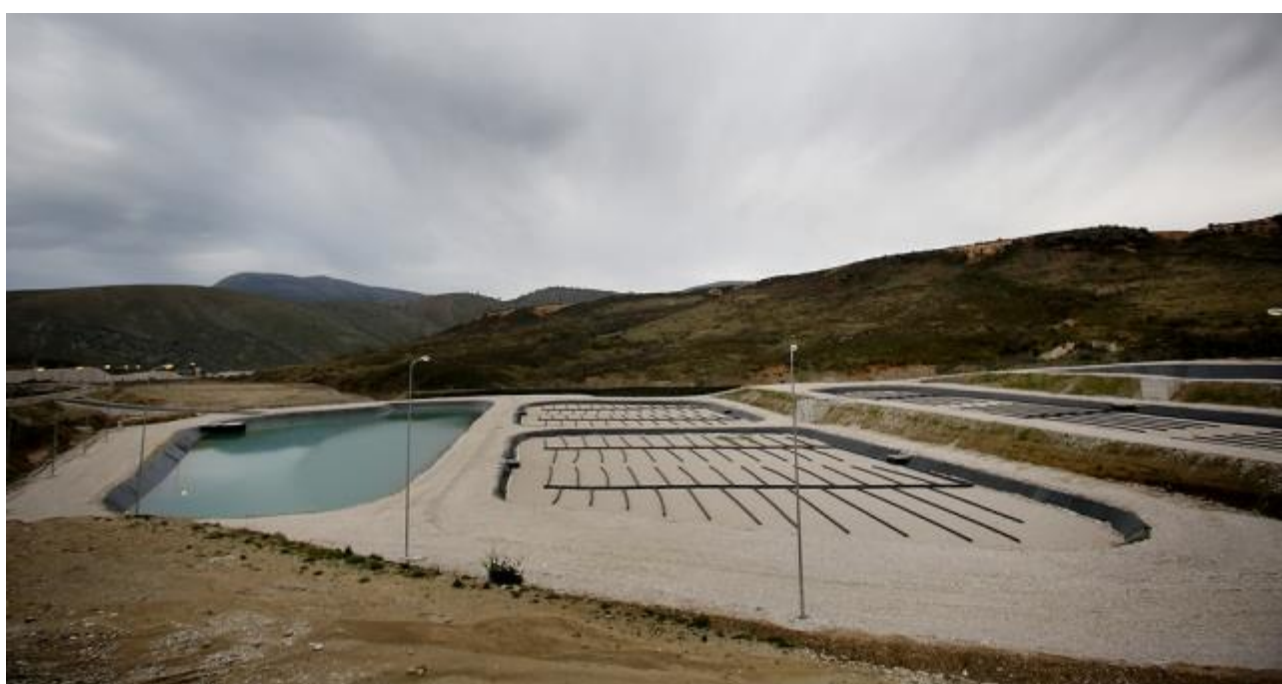
Fig. 7 23 Photo of Bajkaj sanitary landfill

This landfill has been approved with NTC Decision No. 37, date. 10.05.2013 "Complex developing permission for urban waste dumpsite in Bajkaj, Vergo Municipality, Vlorë Region".

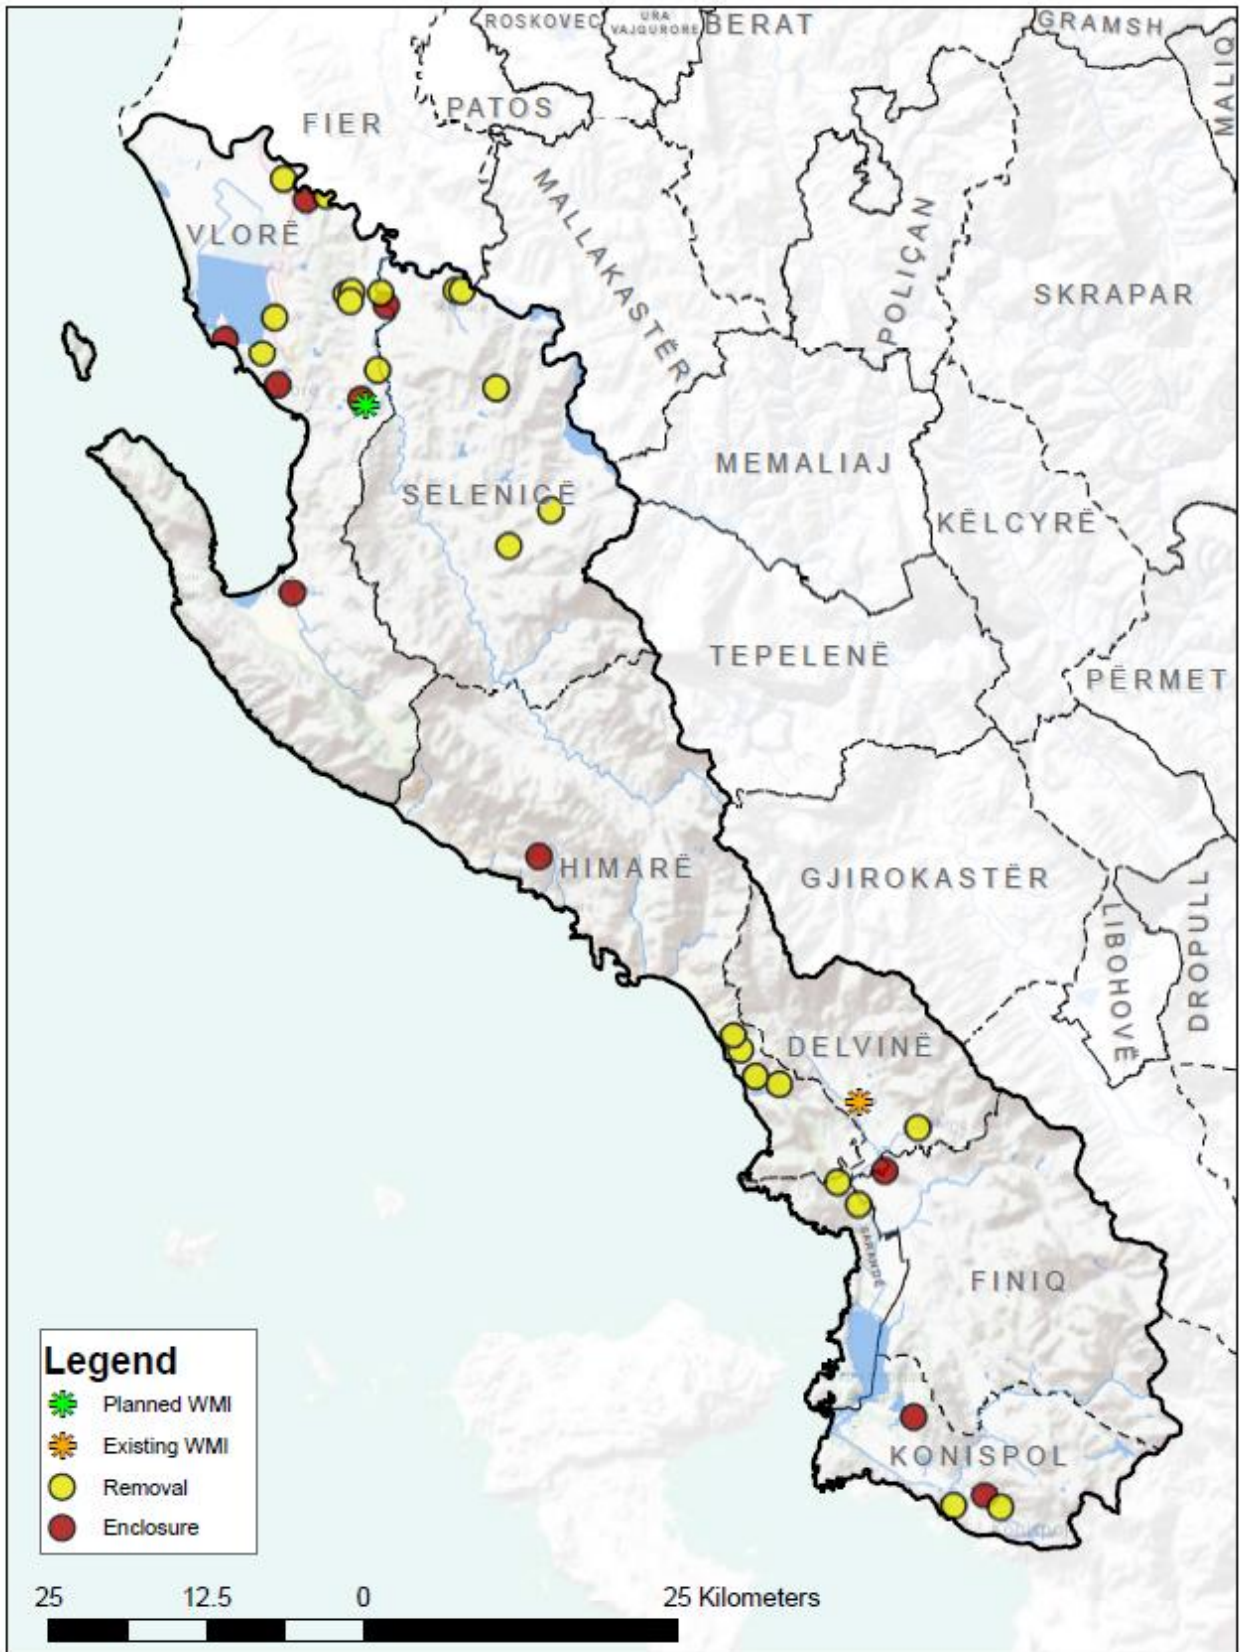
Fig 7 24 Dumpsites in Vlora Region

20		Dumpsite from MUD 2	Removal	508 105
21	VLORA	Dumpsite 2 - N.J.A. Center (Xhyherine)	Closure	1 384 764
22		Dumpsite 5 - N.J.A. Novosele	Closure	2 063 655
23		Dumpsite 1 "Vlore"	Closure	65 346 997
24		Dumpsite 4 - Orikum	Closure	12 220 984
25		Dumpsite 6 – A.U. Shushica	Closure	2 455 802
26		Dumpsite 7 - A.U. Shushica (Sherishte)	Closure	1 518 798
27		Dumpsite 8 - A.U. Qendër (Zvërnec)	Closure	778 442
28		Dumpsite 3 - A.U Qendër (Narta)	Removal	981 372
29		Dumpsite from MUD 1	Removal	342 030
30		Dumpsite from MUD 2	Removal	4 449 529
31		Dumpsite from MUD 3	Removal	1 135 516
32		Dumpsite from MUD 4	Removal	1 917 998
33		Dumpsite from MUD 5	Removal	45 854
34		Dumpsite from MUD 6	Removal	722 318
35		Dumpsite from MUD 7	Removal	192 895
Total cost for Vlora Region				125 328 940
